ROOF RECOVERY

CINEMARK THEATER #1073  
1090 N HILLS SHOPPING CENTER  
ADA ,OK

WALL FLASHING W/ EDGE METAL

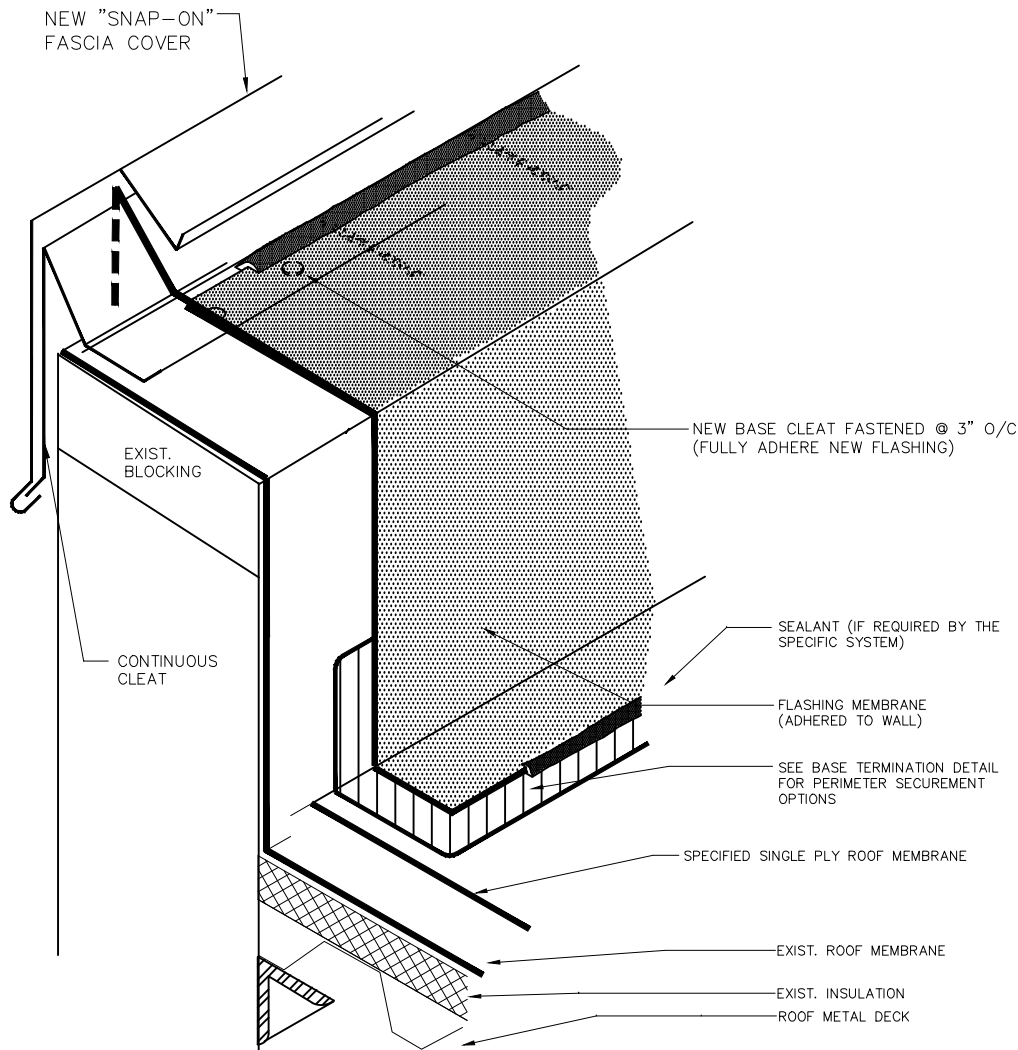
d001

- 1.
2. THIS DETAIL SHOULD BE USED ONLY WHERE THE DECK IS SUPPORTED BY THE WALL.  
TOP LAYER OF INSULATION CAN BE EITHER THERMAL INSULATION OR COVERBOARD INSULATION.
