ROOF RECOVERY

LEDBETTER PROPERTIES
MIDTOWN CROSSING SHOPPING CENTER
224 SHORTER AVE NW
ROME, GA

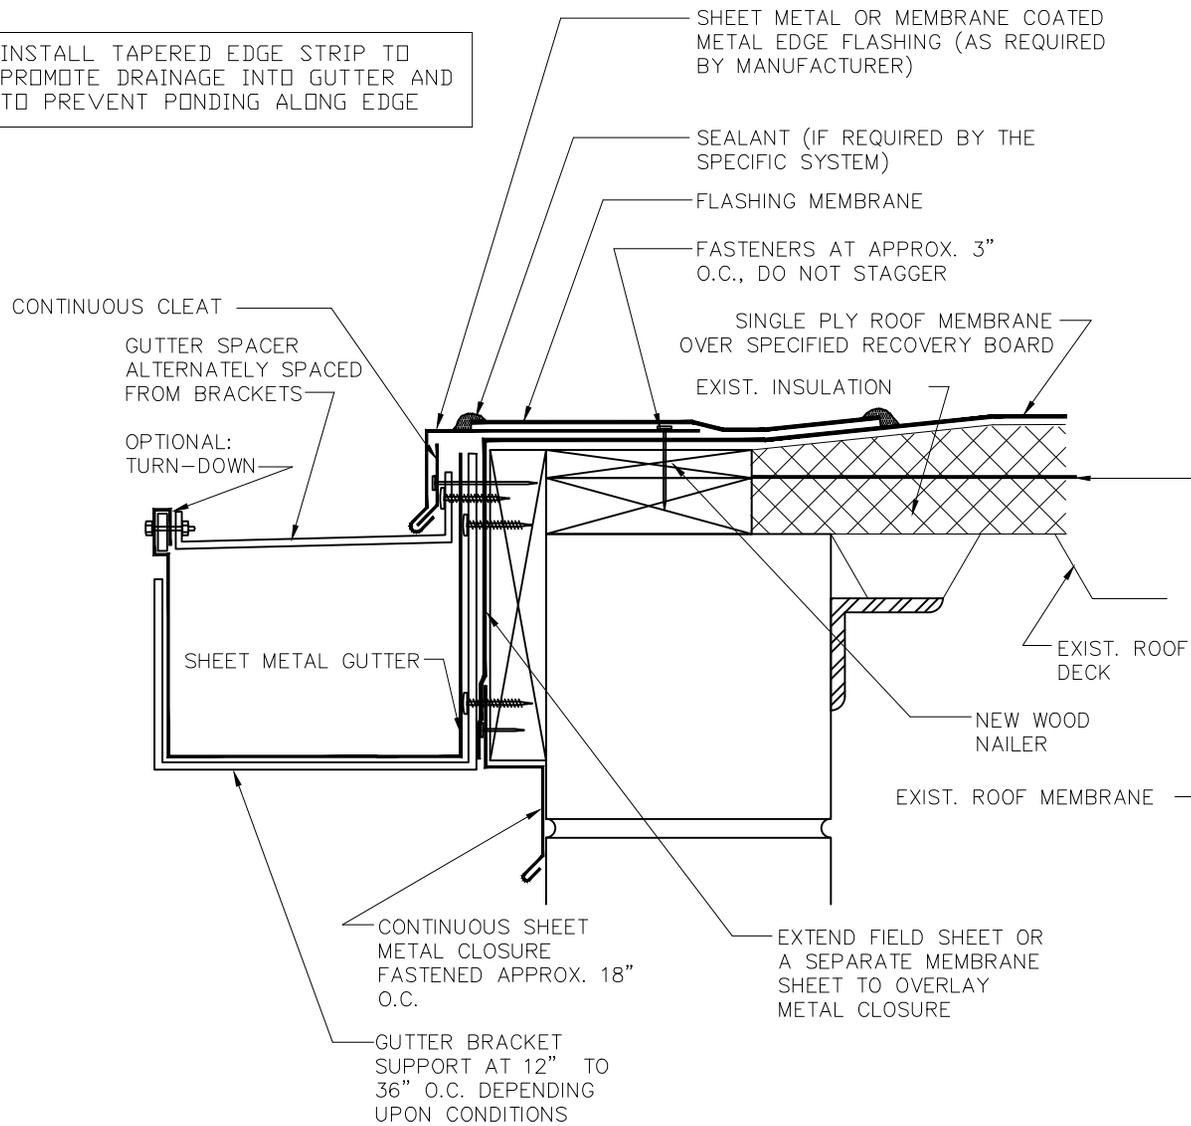
A
04

INSTALL TAPERED EDGE STRIP TO PROMOTE DRAINAGE INTO GUTTER AND TO PREVENT PONDING ALONG EDGE

GUTTER
