GUTTER

ROOF RECOVERY

DALTON SHOPPING CENTER  
(LAS PALMAS & PETLAND)

1349 W WALNUT AVE  
DALTON, GA 30720

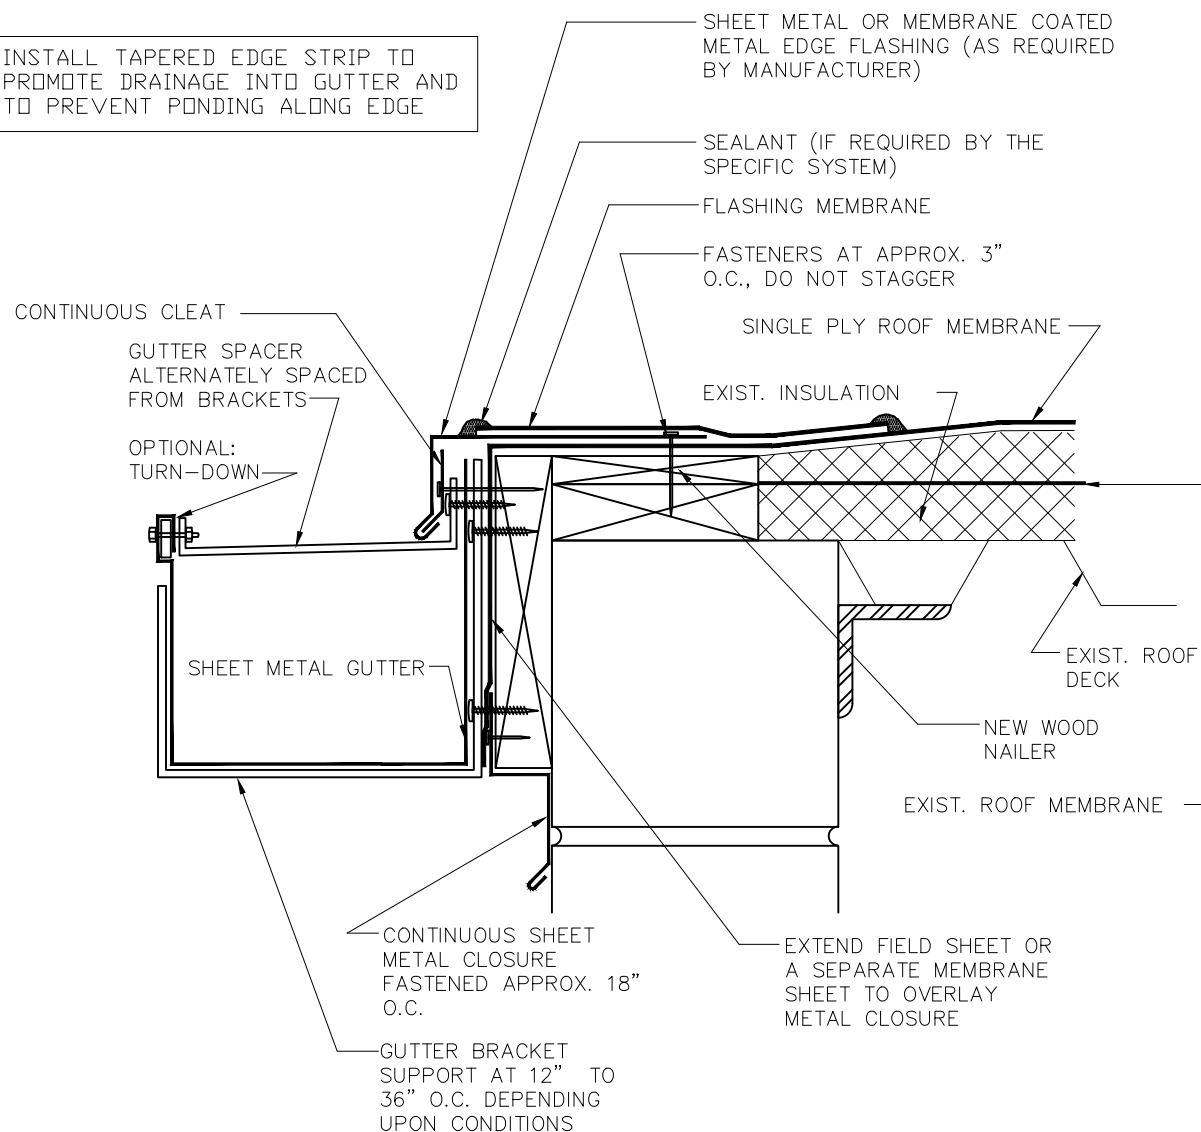
A  
04

INSTALL TAPERED EDGE STRIP TO PROMOTE DRAINAGE INTO GUTTER AND TO PREVENT PONDING ALONG EDGE
