PROJECT TITLE :  
**ROOF RECOVERY**

2026  
 R .H. LEDBETTER  
 PROPERTIES,LLC  
 DALTON SHOPPING CENTER  
 (LAS PALMAS & PETLAND)  
 1349 W WALNUT AVE  
 DALTON, GA 30720

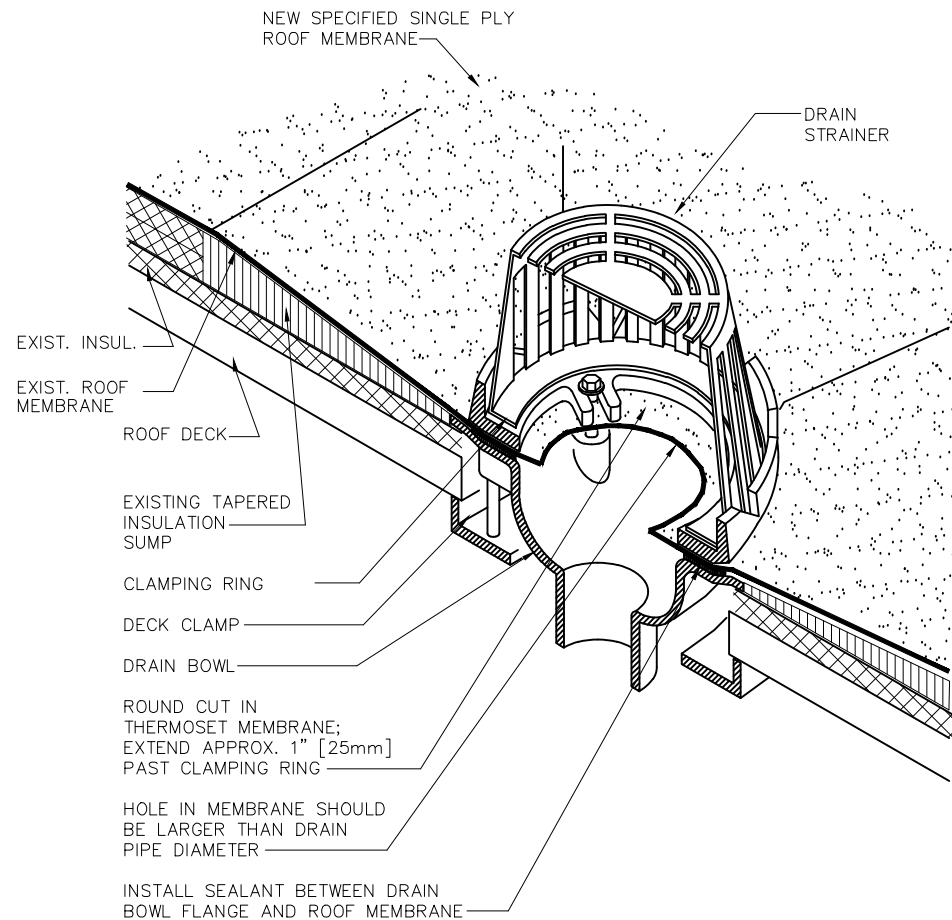
**ROOF DRAIN**

1. THE USE OF A METAL DECK SUMP PAN IS NOT RECOMMENDED. HOWEVER, DRAIN RECEIVER/BEARING PLATES ARE APPLICABLE WITH SOME PROJECTS.
