PROJECT TITLE :  
**ROOF RECOVERY**

2026  
 R .H. LEDBETTER  
 PROPERTIES,LLC  
 DALTON SHOPPING CENTER  
 (LAS PALMAS & PETLAND)  
 1349 W WALNUT AVE  
 DALTON, GA 30720

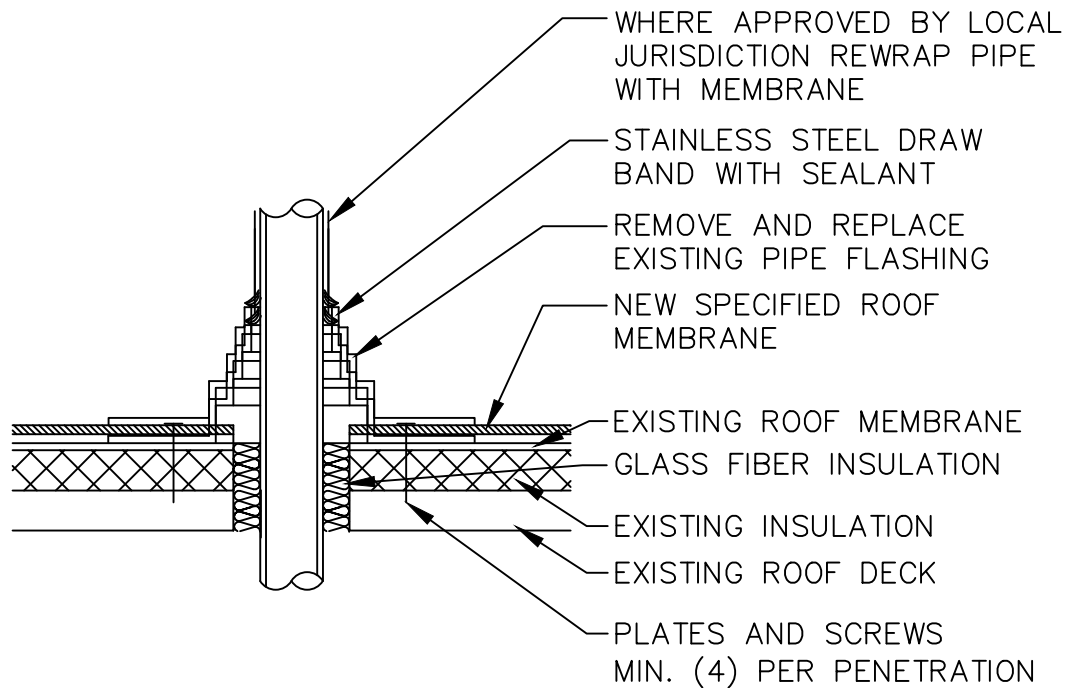
d008

PIPE BOOT
